SBCA TREE CONSULTING

Project: Bike Lane

Subject: Problematic Poplar Tree

Location: Westline Drive and Shorepoint Court (west side)

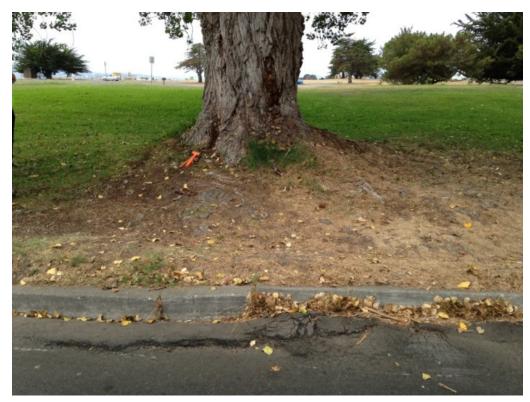
Much of the root system surrounding the tree is on the soil surface. The roots have developed under the street pavement and are uplifting curb and the road surface.

Photo to the left shows the base of the tree looking from Westline Drive. Note street and curb displacement from roots.

<u>Remove Tree</u> – It is recommended that the Fremont Poplar be removed and replaced with 2-3 Lombardy Poplar trees that are the same species as the remaining poplar trees.

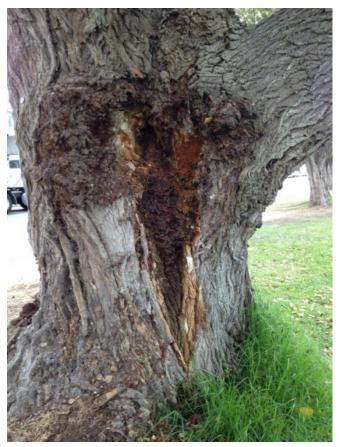
The west side of the tree has a very large wound and cavity. There is also extensive dead tissue in many locations at the ground level. The root crown decay covers about 40% of the circumference.

There are a number of factors that indicate that the useful ness of this tree is near the end. The large size of the tree is a good indication of the age of this tree whose species is relatively shorter lived. The decay cavity and locations of dead root crown tissue accounts for more than 40% of the tree circumference being dead.

Photo to the right shows the cavity in the tree. A significant amount of dead tissue was noted around the base of the tree near the soil line.

<u>Decay Investigation if considered for retention</u> – If there is a desire to retain the tree, it is recommended that a full analysis be undertaken of the level of decay. Due to the large size of the tree, it is recommended that Tomography be utilized in the assessment. Such an assessment is available through arborist Joe McNeil who works out of Pleasant Hill, CA.
